Project Report

PUDDING CREEK

SEWER FORCEMAIN RELOCATION PROJECT

Prepared By
Fort Bragg Municipal Improvement District No. 1
416 North Franklin Street
Fort Bragg, CA 95437

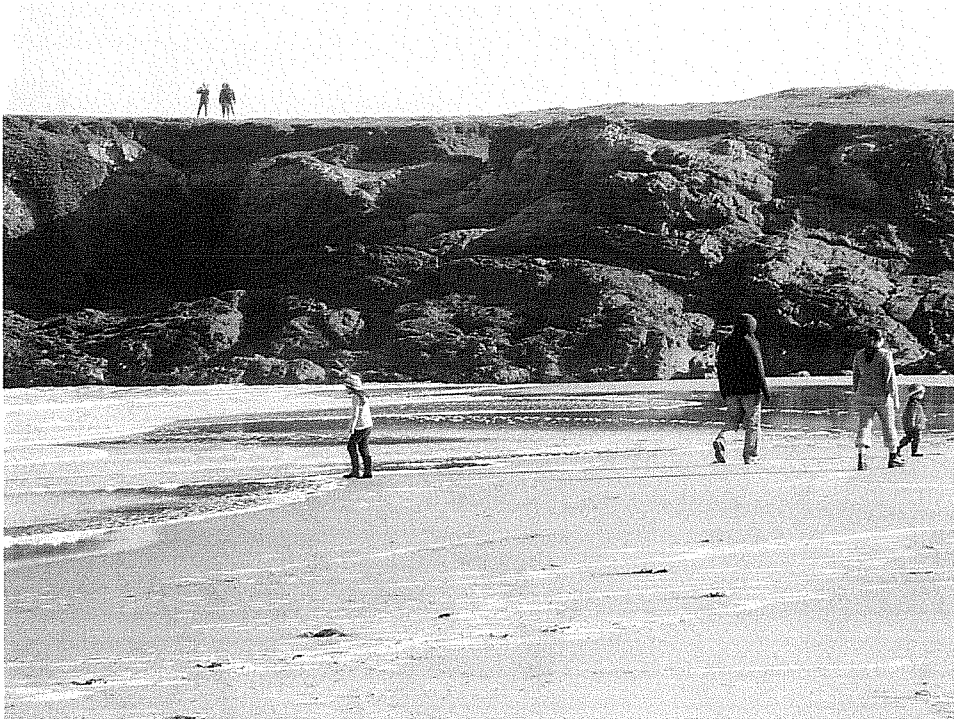
Figure 1. The wave run-up zone at Pudding Creek Beach

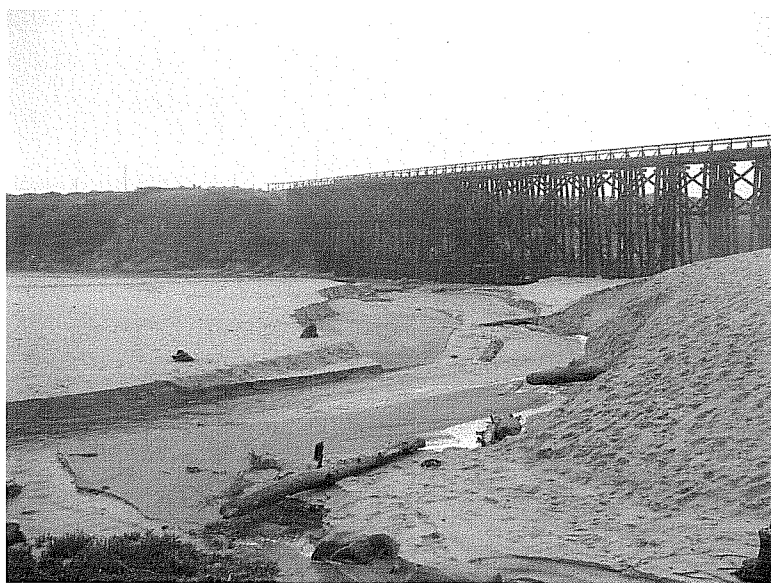
Figure 5. Pudding Creek Beach during a winter storm event

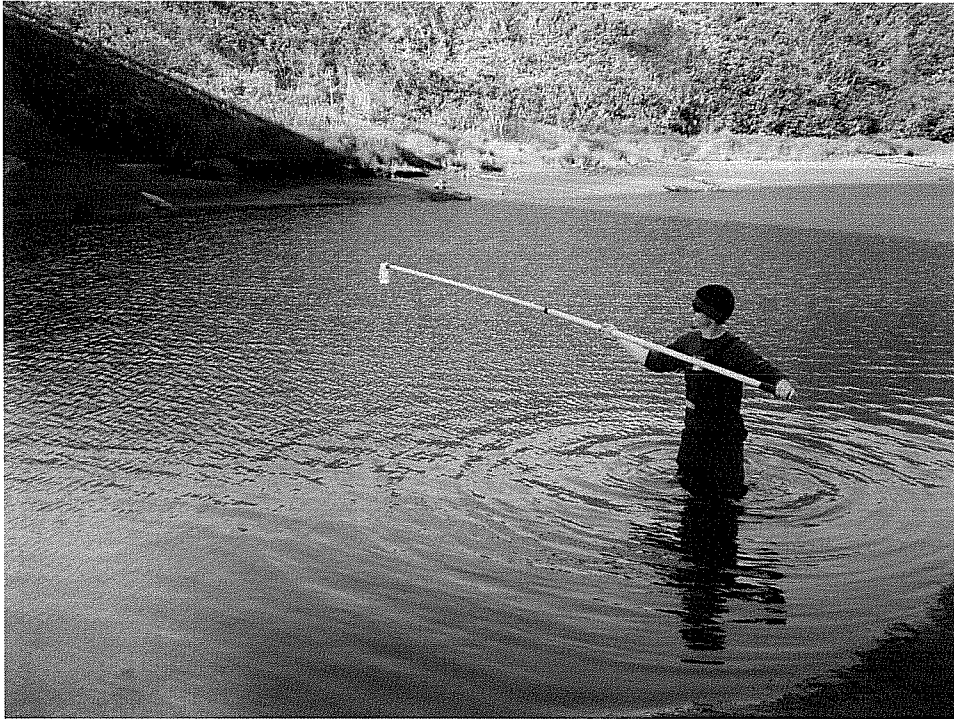
Figure 6. Water Quality Sampling in Pudding Creek at the "Pudding Creek South" Location near the Pudding Creek Bridge by a specialist from the Mendocino County Division of Environmental Health

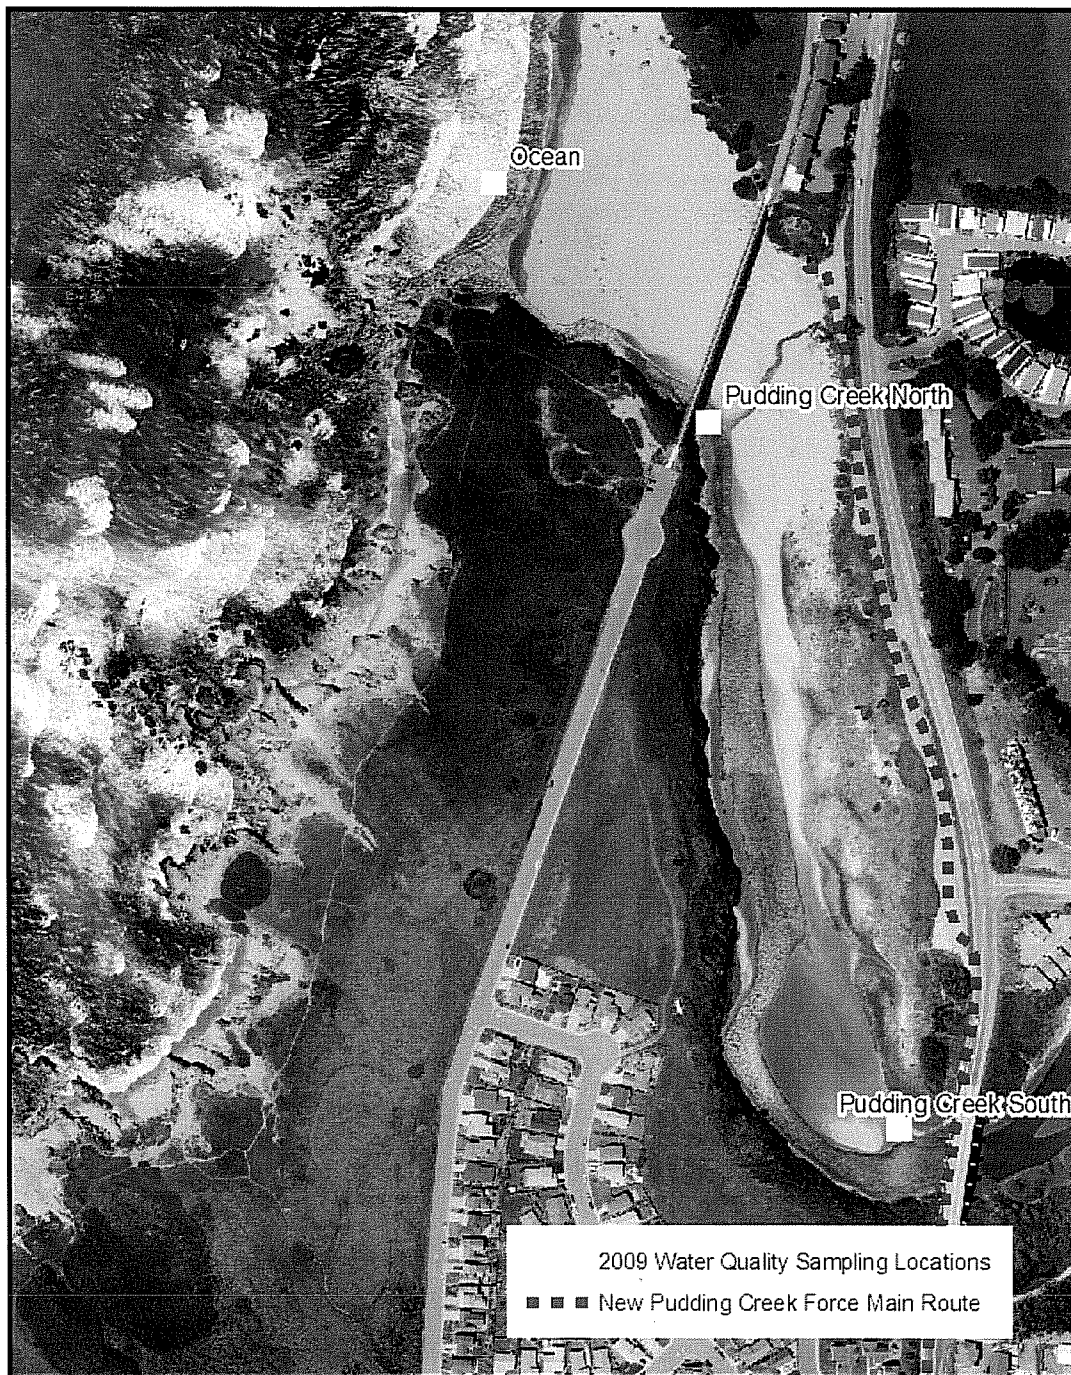
Water Quality Sampling Locations

Figure 7. Monitoring Locations for 2009 water quality sampling at Pudding Creek Beach.

As a part of the grant agreement scope of work, the City collected water quality data from surface water at Pudding Creek Beach. This data was collected by Mendocino County Department of Environmental Health. The results of the sampling and testing are summarized in this report. Water quality samples were collected at two locations in Pudding Creek Lagoon and one location in the surf zone of the confluence with the Pacific Ocean at MacKerricher State Park (see the following map - "Water Quality Sampling Locations").

Monitoring program commenced in April 2009 and continued through October 2009. The sampling data was collected weekly at the three locations shown on the previous page. The frequency and duration of the sampling was consistent with AB411 requirements.

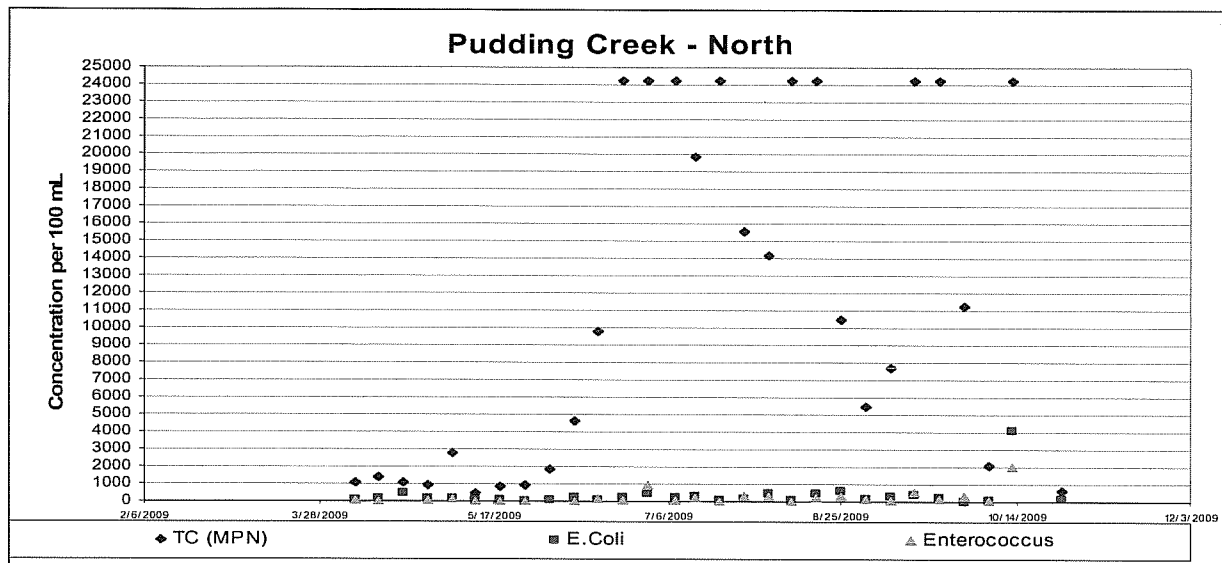
Figure 9 – The concentration of bacteria per 100 mL in the north sampling location at Pudding Creek Lagoon. TC is Total Coliform. E.Coli is fecal coliform

Concentrations of bacteria in the lagoon water exceeded water quality standards during the sampling period. The following table lists all of the exceedances in the Pudding Creek North sampling location. This location is adjacent to the popular sheltered beach, while the Pudding Creek South location is not used as heavily as the banks are vegetated.

Table 1. Dates of Exceedance of one or more bacteriological water quality standards at Pudding Creek North Sampling Site

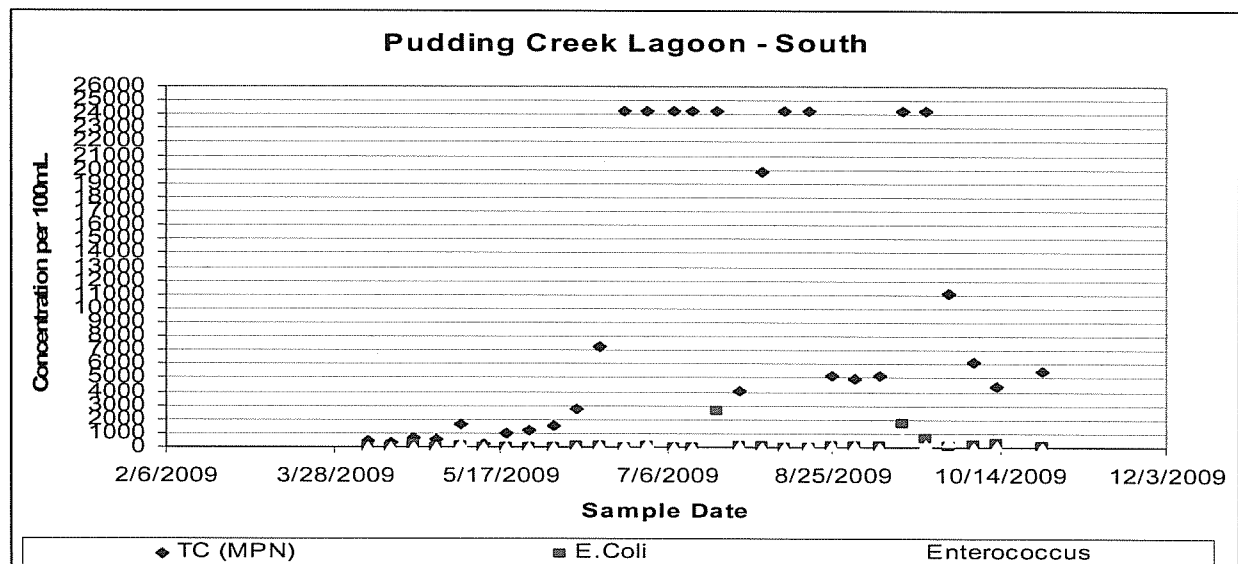
Figure 10 – The concentration of bacteria per 100 mL in the south sampling location at Pudding Creek Lagoon. TC is Total Coliform. E.Coli is fecal coliform
